# Slating, tiling and roof plumbing

## Introduction

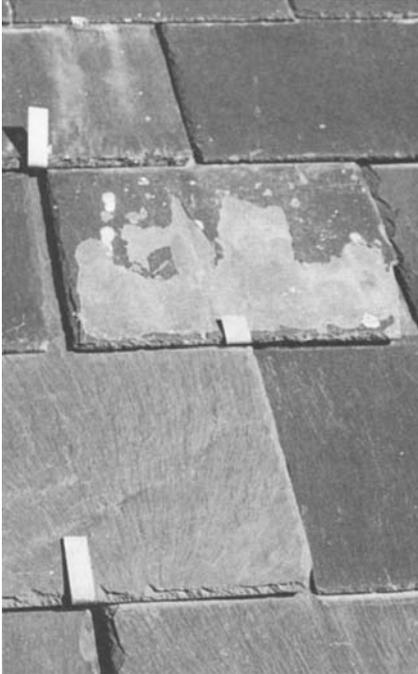
*These slates have begun to delaminate and may need replacing in the future.*

Apart from these items, slate roofs may be defective due to delamination of the slates caused by weathering, or slipping of slates caused by nails rusting out. Delaminated slates have a dull sound when struck, quite different from the clear ring of a sound slate. Slates in the gutter are often a sign of rusted nails. Water stains appearing as thin streaks down the slates may be an early indication of nail failure.

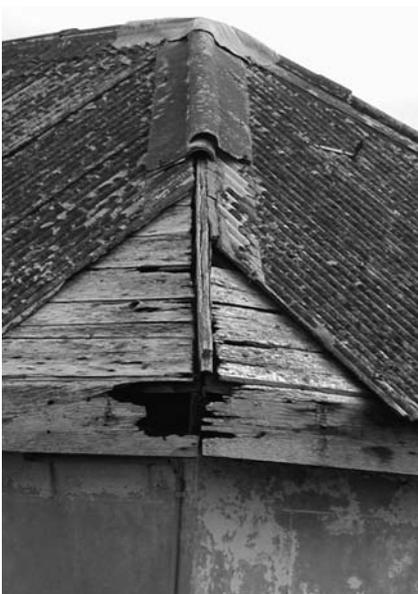
*Removal of part of the roof on the keeper's cottage at the South Solitary Island Light Station has revealed the sarking beneath. The roof was formerly slate, and was replaced with corrugated asbestos.*

Sarking (a waterproof underlay to the roofing) did not come into general use until recently. However, many early slate roofs had timber boarding over the roof structure to act as a secondary barrier to water entry, as well as cross-bracing for the roof. Provided the slope of the roof is adequate for the weather, sarking is still not essential for watertightness, but is a sensible second line of defence against roof leaks. It should be placed between the battens and the rafters. Sarking should only be used where there is no boarding, and where all the battens need replacement and have therefore been removed.

Early sarking was made of a bituminous material which is highly flammable. Unless the existing sarking is sound and of heritage significance, it may be desirable to replace it with a modern fire-resistant type.

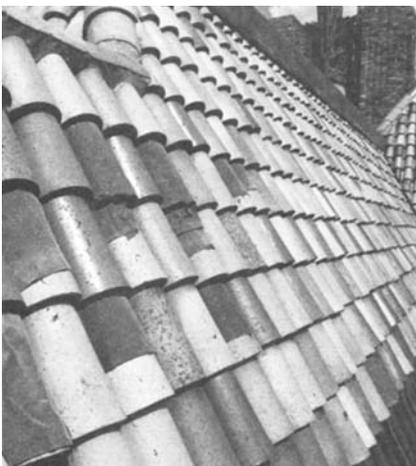
*Traditional colour variations in terracotta tiles.*

Old terracotta tiles were made in stack kilns in a similar way to bricks. The process resulted in different degrees of firing, those tiles closest to the fire being overburnt and those furthest underburnt. When glazed tiles appeared, there were more variations in the thickness of salt glazing, which was applied by hand. The manufacturing process thus resulted in natural variations in the colour of the tiles, and accounts for the motley colours of a traditional terracotta roof. Modern terracotta tiles are made in a tunnel kiln using highly controlled composition and temperature, and emerge very uniform in colour. They may therefore not be suitable for re-roofing an old building.

Tiles are still made by traditional methods in some parts of the world, and can be obtained with an appropriate mix of colours. Alternatively, matt glazes have been used with some success to produce slight colour variations simulating the traditional appearance.

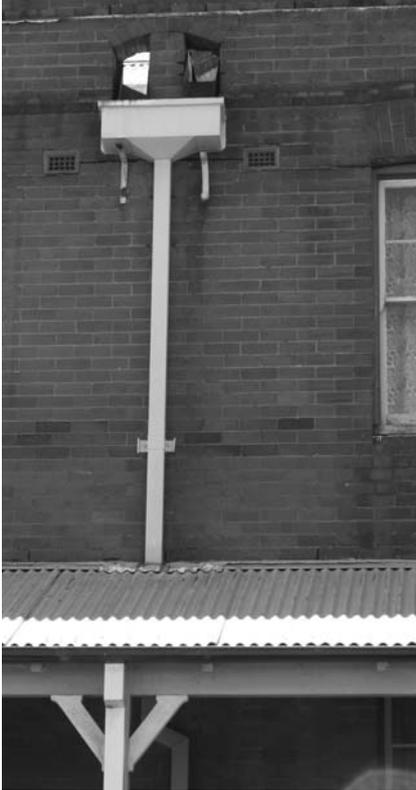
*Traditional rainwater head,  
Gloucester Street, Sydney.*

Those elegant boxes at the top of downpipes are not just pretty decoration. The purpose of the rainwater head is to provide a large catchment area to slow and dissipate the energy of the horizontally moving water from the gutters. Gravity then takes over and the mass of water in the head drives the water down the downpipe much more effectively than without a head. Repair and maintenance of rainwater heads is therefore good building management practice as well as good conservation.

Rainwater heads should always have an overflow spout, so that in the event of blockages excess water is directed away from the walls below. They should also have wire mesh covers or baskets in a design that will not encourage bird nesting.
